Geo-Scientific Evaluation, Kinematics Analysis, and Mitigation Strategies for Pagal Nala landslide along Rudraprayg to Joshimath (NH-07) road corridor, Garhwal Himalaya

Nalini Das¹, Rajendra Kumar Rawat²

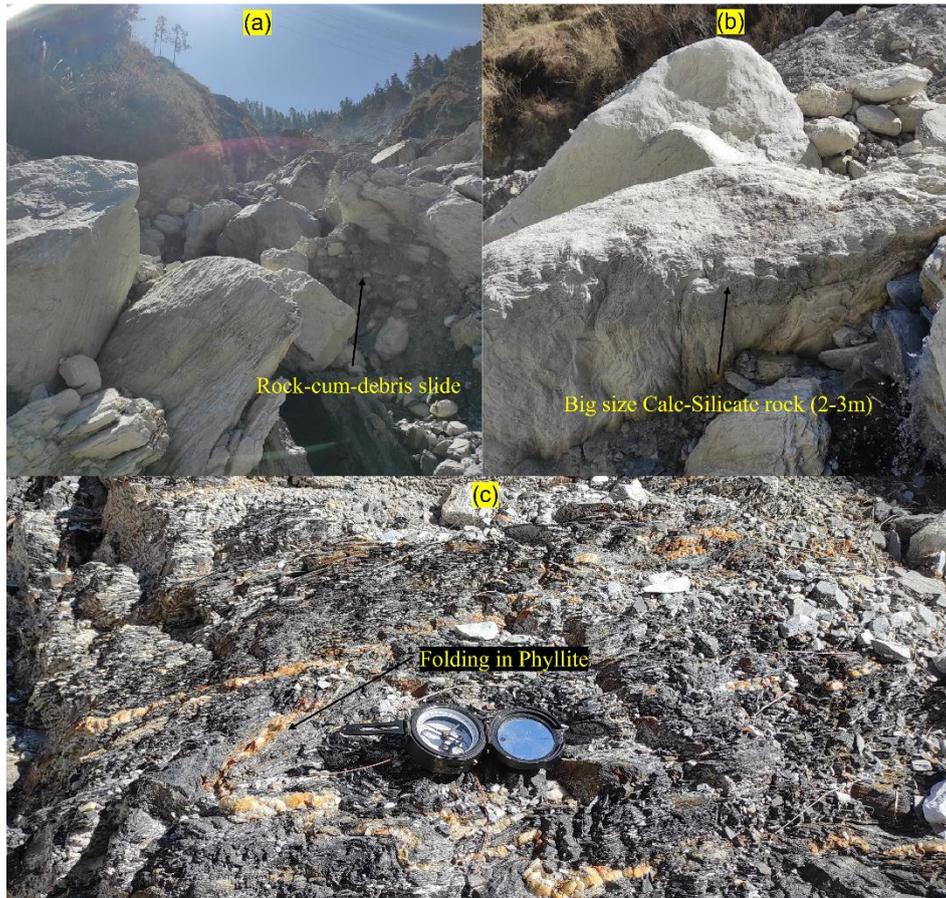
Fig. 2 Pagal Nala landslide, (a) slide view showing rock-cum-debris slide, (b) big size boulder of calc silicate rock (2-3m), (c) folding seen in phyllite

The Pagal Nala landslide, situated along the Rishikesh–Mana highway (NH-07), is a significant and recurrent slope failure influenced by both geological and anthropogenic factors. Unengineered and unplanned road construction have destabilised the toe part of the slope, as can be seen from **Fig. 2**, in which natural support loss has created further instability. Destabilisation together with intensive monsoonal rainfall has led to frequent landslide occurrences. As most of the displaced material would be in the toe portion, every rain event introduces further reactivation due to saturation, pore water pressure rises, and reduction in the shear strength. **Fig. 9** is a clear indication of the accumulation of mixed debris and overburden material in the toe, confirming the

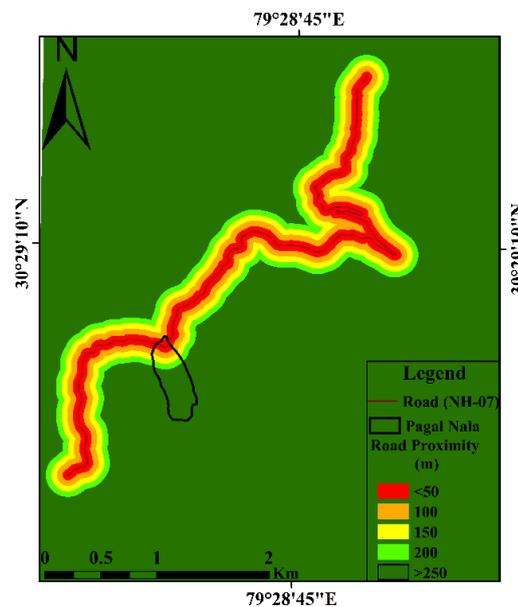
Proximity to the road has been a controlling factor in the Pagal Nala landslide by directly affecting the slope stability, specifically in the toe zone (Woldearegay, 2025). The road, as shown in the proximity map, follows or cuts the toe of the slope, where repeated excavation and widening have eroded natural support, resulting in toe undercutting (**Fig. 4**). This upsets the slope equilibrium, especially in a section consisting of weathered and interbedded lithologies. Secondly, poor drainage management and roadside litter dumping also increase surface runoff, leading to saturation and erosion. The road proximity is therefore an important human landslide cause.

Fig. 4 shows the Road Proximity map, where road cuts the toe portion of the slide.

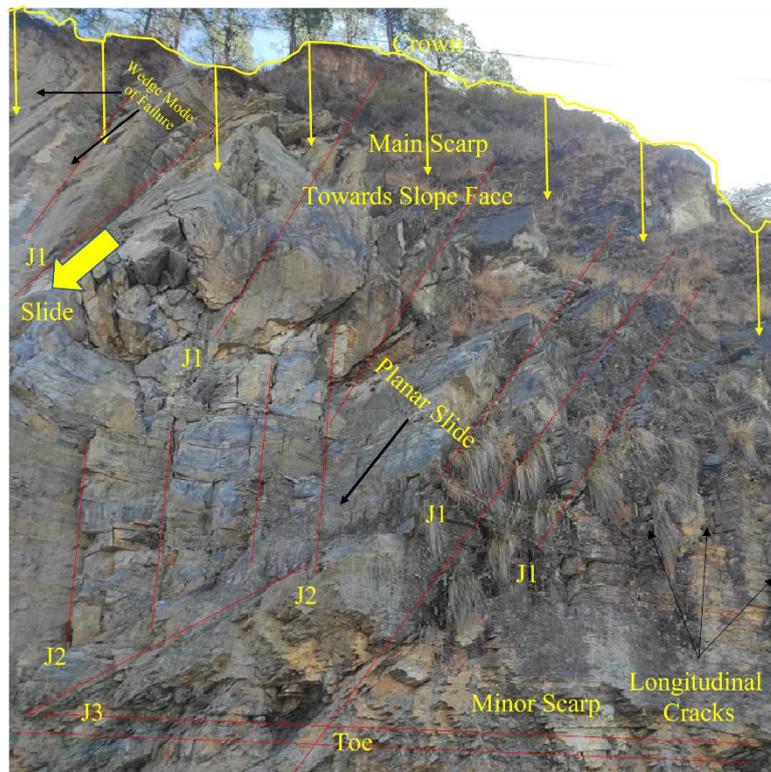
Fig. 7 Near side of Pagal Nala landslide (quartzite) where three sets of joint planes are well shown and demarcated.

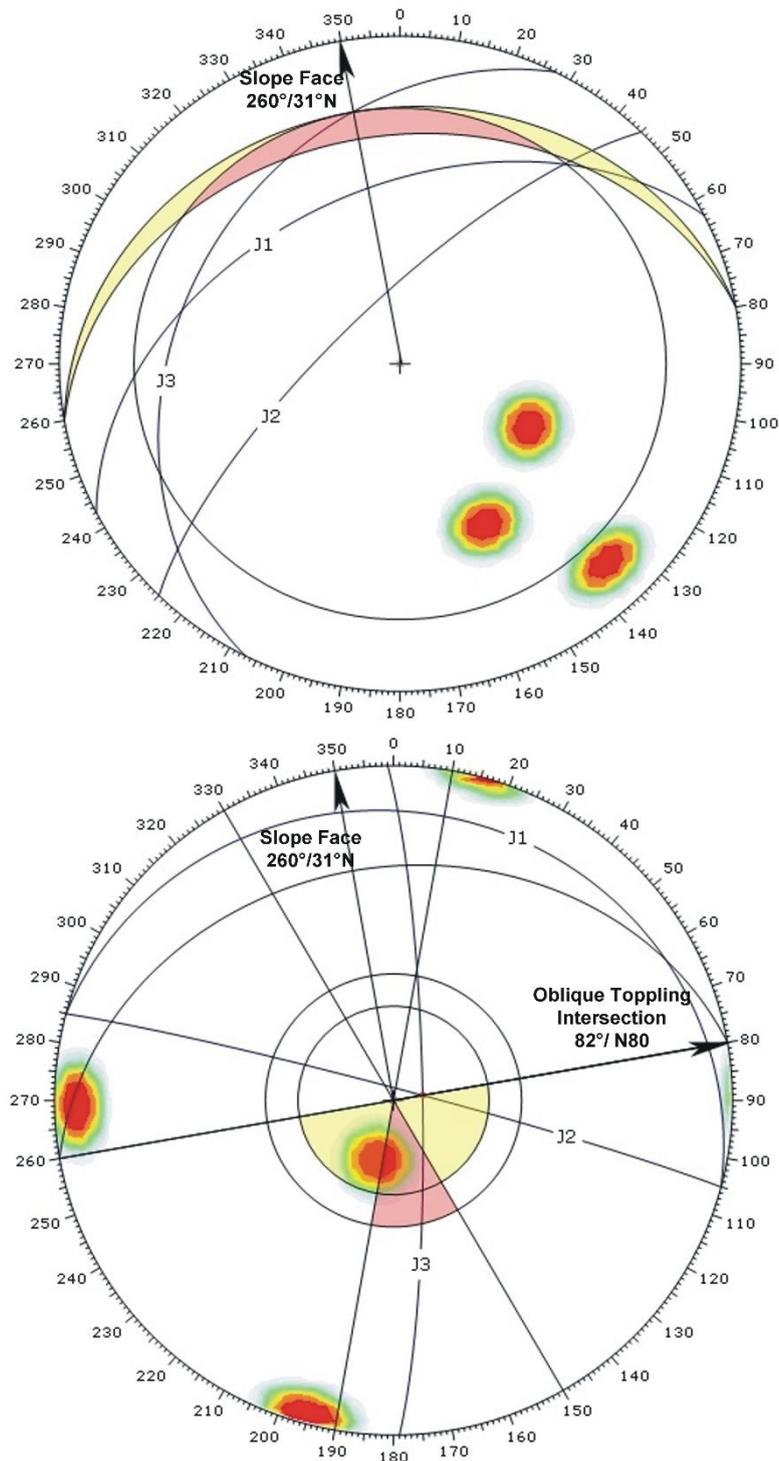
Kinematic analysis is a method used to determine the probability of various failure modes in rock slopes, which is controlled by the adverse orientation of discontinuities (Olaleye & Ajibade, 2011). Testing is performed via structural measurement and follows Markland's test criteria, according to Hoek and Bray (1981), conducted with Dips software (Siddique et al., 2015). The lithology is characterized mainly by quartzite and calc-silicate rocks that, even though they are mostly competent, have degraded shear strength owing to the presence of structural discontinuities in joints, faults, and fractures (Fig. 7). The orientation and persistence of such discontinuities have an important part to play in slope stability, especially under faulted ground and zones of active surface run-off or gully erosion. Table 1 gives two sets of discontinuity orientation data that were gathered to determine precisely the structural orientation of the Pagal Nala landslide. In Set 1, no discontinuities are clearly showing planar or wedge failure tendency, although J1 is inclined towards planar failure. In Set 2, J2 and J3 intersection shows oblique toppling mode of failure with plunge angle of 82° towards N80°, and J1 continues to show planar failure susceptibility. Two sets of joints are represented in Fig. 8.

Fig. 8 Kinematics analysis at Pagal Nala landslide. Set 1, no discontinuities are clearly showing planar or wedge mode of failure. Set 2 showing oblique toppling mode of failure (J2 & J3 joint plane intersection)

Pagal Nala landslide, caused by differential weathering, rain infiltration, active toe erosion, and uncontrolled road cutting, demands site-specific remedial measures. Contour drains and cross-drains should be installed across the surface and subsurface flow. A breast wall with weep holes, supported by competent bedrock and graded filter provision, will ensure pore pressure rise prevention and debris trapping. To mitigate stream-induced toe erosion, stepped chute drains and check dams are advocated. Wire mesh anchorage, rock bolting, and geo-textiles should anchor at distressed slope sections particularly where toppling and planar failures are kinematically possible.

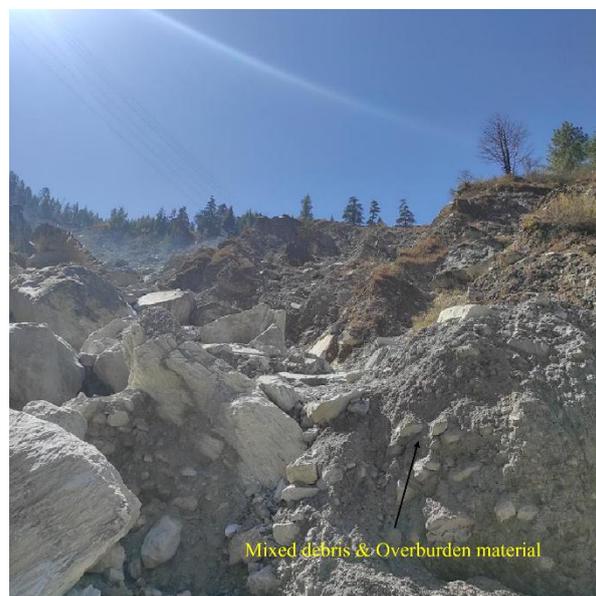
Fig. 9 Accumulation of mixed debris and overburden material in the toe portion of the slide.
