## A Case Report-Neck fracture of a cemented stainless-steel femoral modular stem, 8 years after Total Hip Arthroplasty

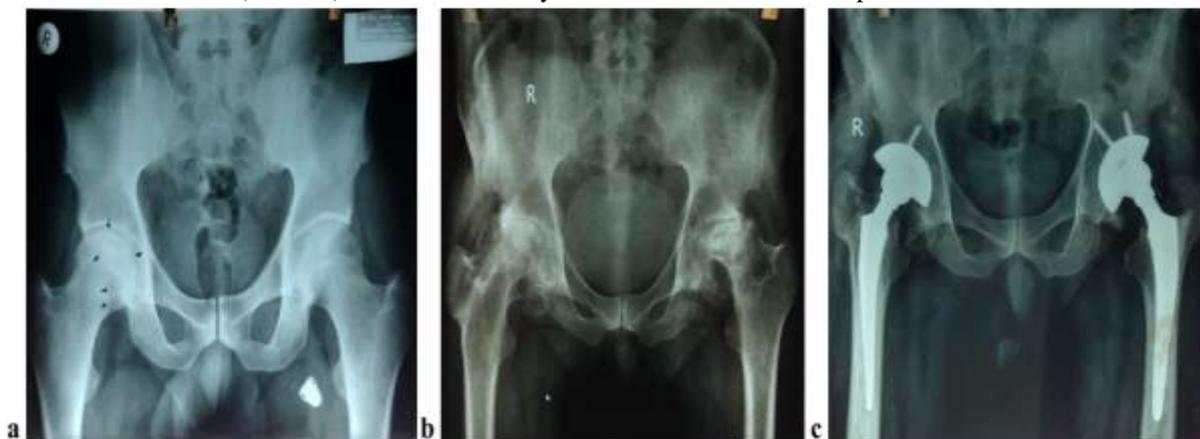
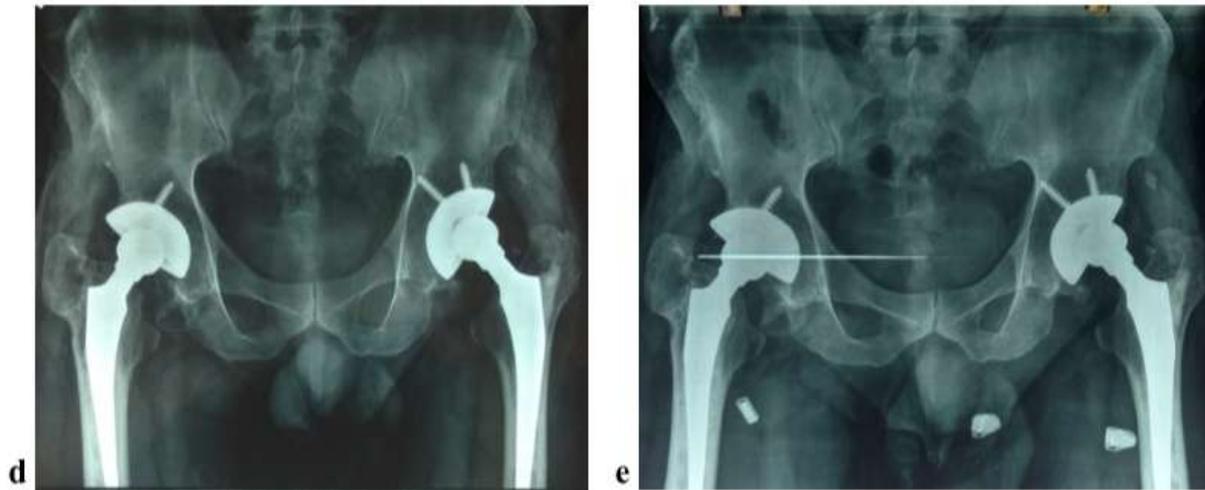
**Figure1.** Pelvis with both hip joint x-ray (a) Year 1998 x-ray showing involvement of right head; (b) Year 2007 x-ray with involvement of bilateral hip joints; (c) Post-operative x-ray; (d) One month follow up; (e) One year follow up.

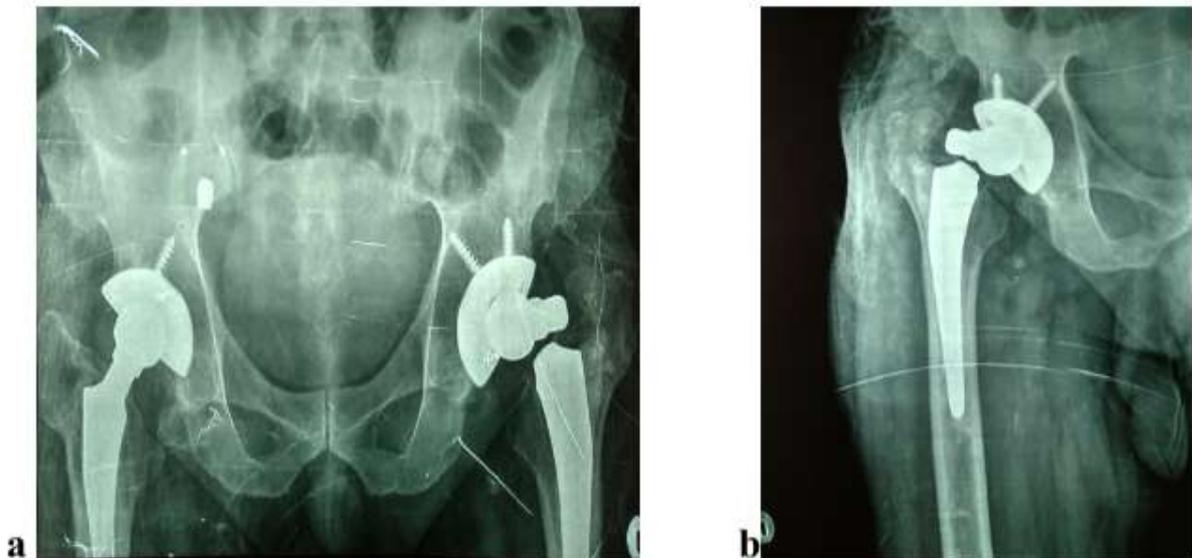
In April 2015 (8 years postoperatively), the patient had a trauma due to fall on left hip. Following the event, he presented to our casualty department with pain and was unable to bear weight. There was clicking sound on hip examination. Radiographs were taken which showed bilateral hip arthroplasty with fracture of left sided femoral stem neck without any involvement of bone.

**Figure2.** (a) Anteroposterior view of pelvis with both hips showing left broken femoral neck. (b) Anteroposterior view of hip joint with femur showing broken implant with no bone fracture.

The patient was planned for revision dual mobility Hip Replacement Surgery. Southern approach was taken to extract the acetabular cup with liner and screw. The femoral component could not be retrieved by stem

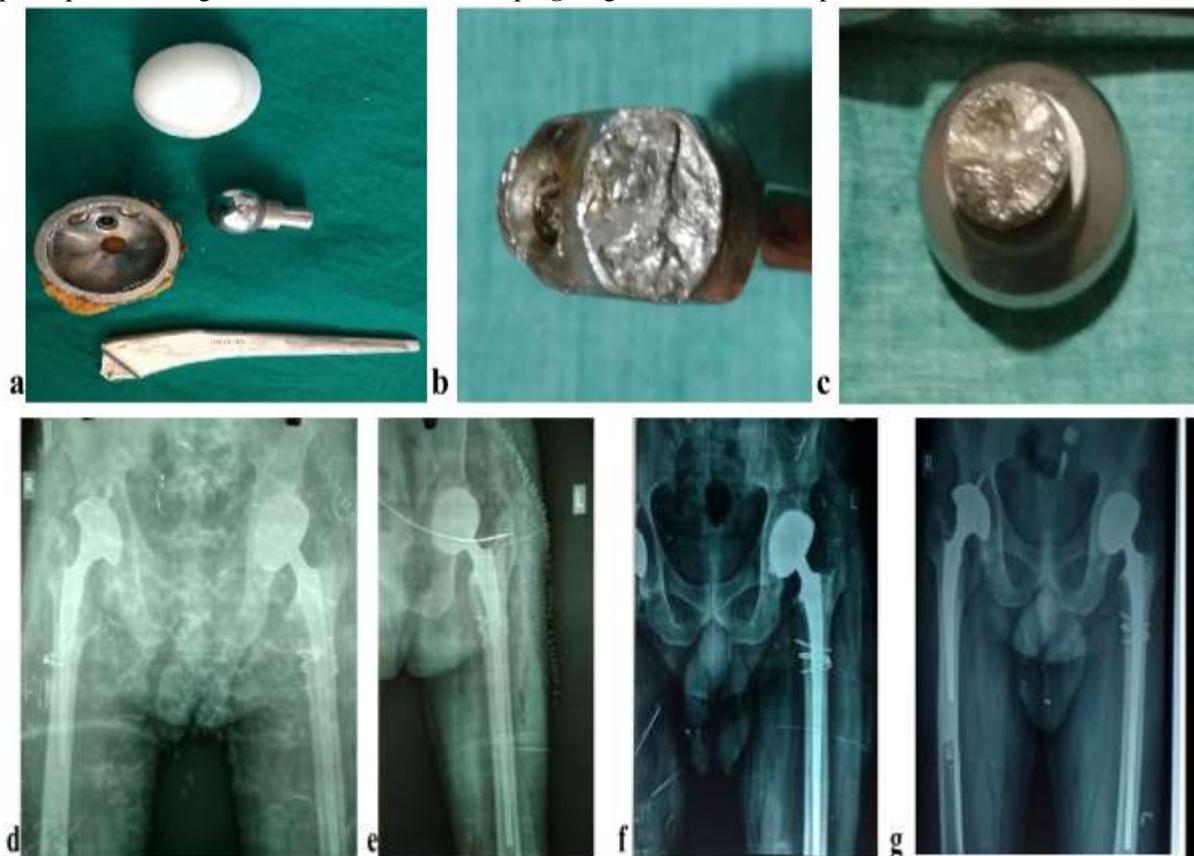
extractor, so we utilized trochanteric osteotomy to remove femoral stem and cement extraction. The extracted femoral stem showed fracture at tapered smallest cross-section of neck of femoral stem. The polyethylene liner showed normal aging. Impaction bone grafting with allograft was done prior to placement of cemented ADES dual mobility cup (56mm) with insert of longer neck (Modular Head –Muller Type; 28, +3.5 long) for better abductor mechanism. To achieve better fixation in shaft; large femoral stem of Muller Type with (7.5XL, length 250mm) was used. Osteotomy was closed with stainless-steel Tension banding wire encircling. Post-operative course was uneventful; patient was mobilized on third day with partial weight bearing supported by walker. At follow-up examinations, eight months postoperatively, the patient remains independently mobile and pain free with a good range of motion having Harris Hip Score of 90.

**Figure 3.** (a) Extracted total hip prosthesis, (b) and (c) Margin surface of broken femoral neck, (d) and (e) are post-operative images, (f) Four months follow up, (g) Eight months follow up.

Femur neck works as a lever arm in balancing forces across the joint. It is subjected to unsymmetrical stress along its varied diameter. Taper design of the implanted femoral stem with fixed neck; produce significant loading at the smallest cross-section point. Factors contributing to fracture include defects in welding of the neck to the prosthesis [13], heavy laser etching in the region [14], and crevice corrosion associated with the head-neck junction [15]. Vatani et al. observed 9 fractures though the neck of femoral stem in 35 total hip arthroplasties using a Charnley type modular 28 head [16]. The fractures occurred after mean 4 (0.3–6) years. All fractures were due to an inadequate confluent radius causing abnormal transmission forces through the neck.

Femoral stem fracture cannot be attributed to a single cause. Various modalities work at different level leading to increased wear and tear in implants. The repeated insults to vulnerable point add up over the years leading to its breakage. In this case, patient's heavy body with tall stature and high working causes increased stress over the narrow neck of stainless steel implant over the years. Finally causing fatigue fracture at the neck stem junction.

These adverse events could be prevented by using chromium-cobalt or titanium prosthesis having higher yield and better strength. Newer modular designs also have higher yield and better strength.
