# Structural Health Monitoring And Repairs: A Case Study From Mumbai

This paper presents a case study of a two story (G+2) institutional building, it is framed structure made of RCC columns, beams & slabs. Age of the building is in the range of 47 to 50 years as per the construction. Structural audit was conducted for proposed repairs, rehabilitation, and retrofitting of an existing building. The structural health monitoring was conducted using visual inspection, detailed distress mapping, and non-destructive tests. The structural health monitoring is a crucial tool for assessing the condition, serviceability, and safety of the structure. It helps in identifying risk areas, critical areas, and the need for immediate attention. The structural health monitoring also investigates the impact of changing the building's use from residential to commercial or industrial on its performance. The purpose of the audit is to save life and property, assess the extent of distress, estimate the residual life of the structure, highlight critical areas, advise residents/owners/users about the problems' seriousness, comply with statutory requirements, and select an effective remedy. This paper empha

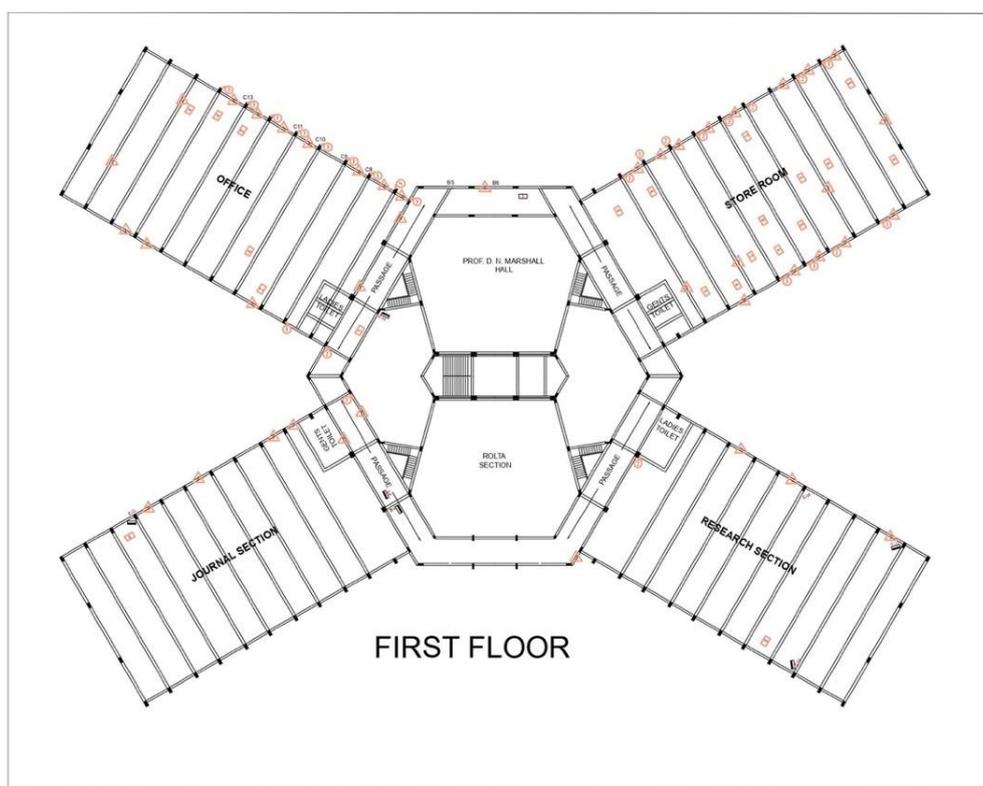
Fig.2 Distress Mapping on Plan for First floor

It can be concluded that the building structure is not in dilapidated condition. However, few RCC elements primarily beams, columns, slab needs urgent structural repairs. If adequate structural repair, strengthening & retrofit measure are undertaken then enhancement in service life of the building structure can be achieved. To prevent mishaps and/or casualties Vertical props should immediately be provided at C & D wing on 1<sup>st</sup> floor where the slabs & beams are observed in severely deteriorated condition (Refer Distress mapping plan).

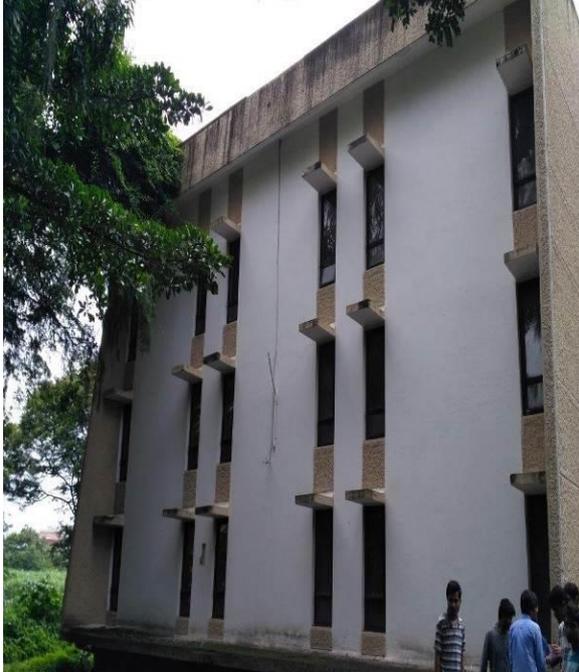
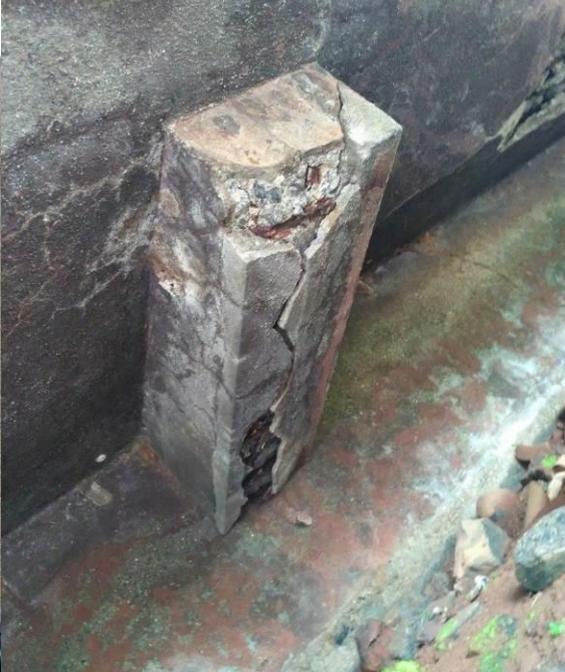
Face A: Front view; External plaster is in distress condition with minor cracks, algae, moss formation.	
Face B: Full view	Face B: Minor cracks in columns & Vegetation growth observed at plinth protection.

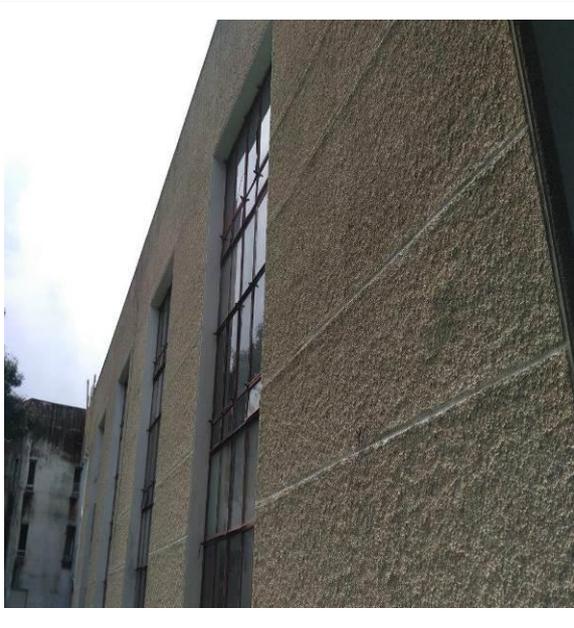
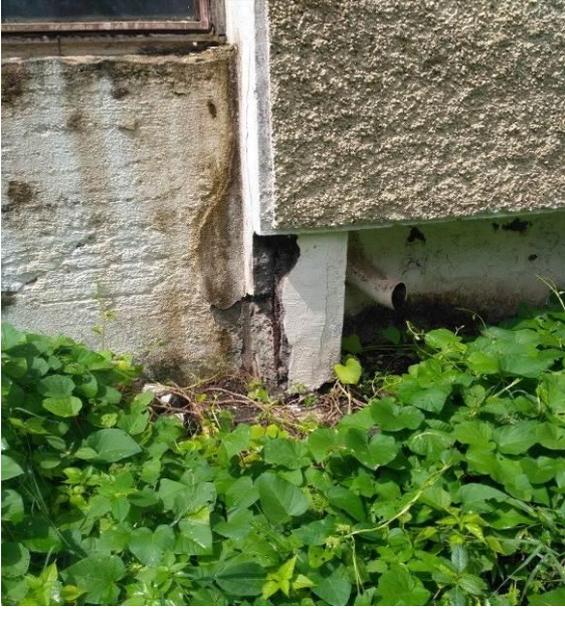
Face C: Minor cracks on wall plaster, cracks on elevation pardis with moss formation	Face C: Beam is in damage condition with exposed reinforcement & wide crack.

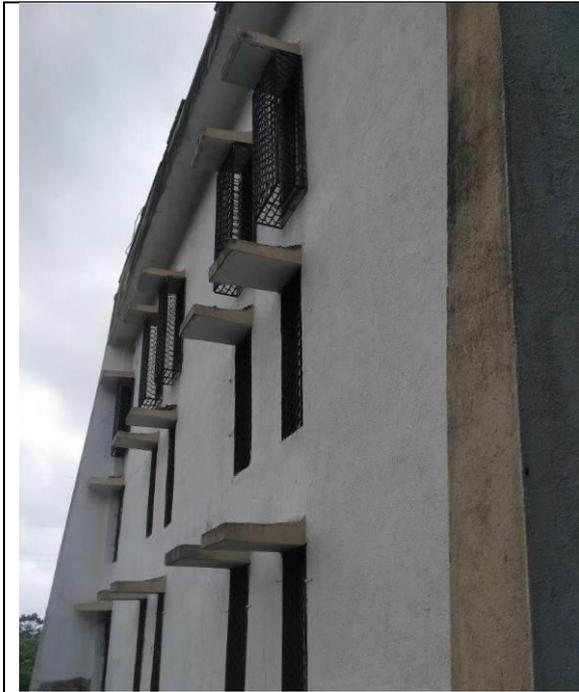
Face D: vegetation growth on plinth protection, columns damaged with fallen cover concrete, exposed and corroded reinforcement.

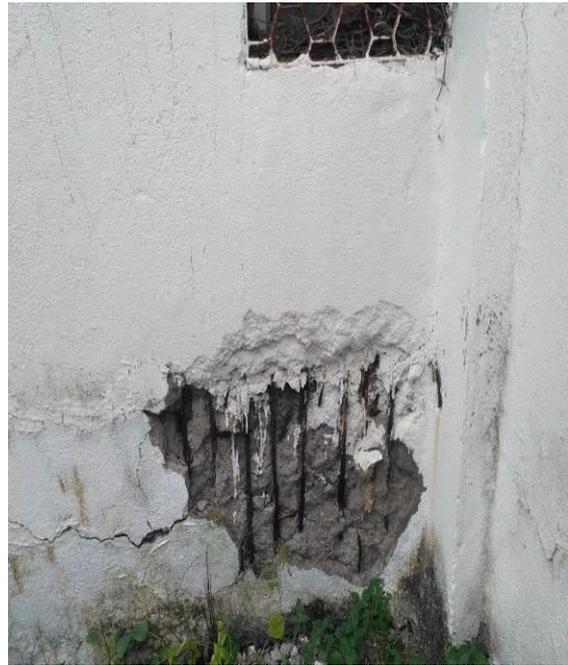
Face G Minor plaster cracks on walls, Vegetation growth on plinth protection.

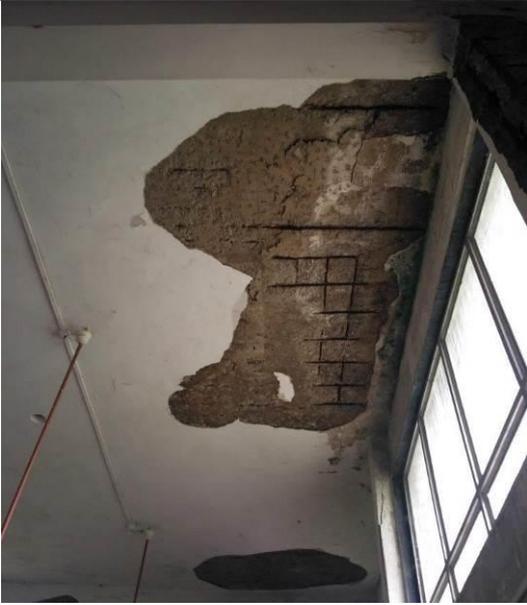
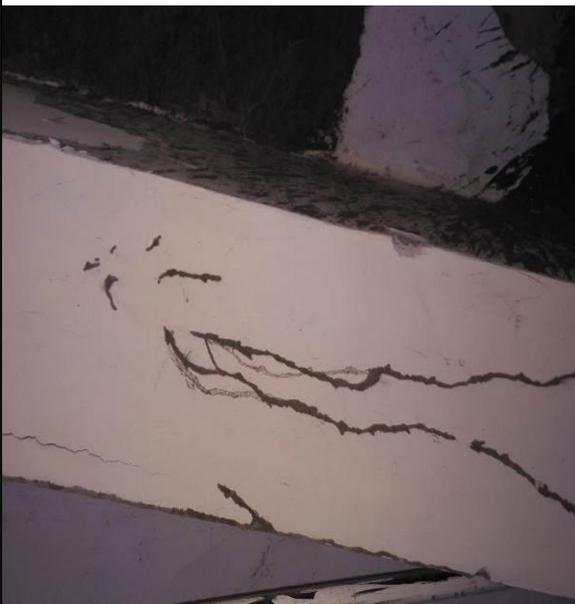
<p>Ground Floor Common Passage: Reinforcement exposed and corroded of slab with delamination of cover concrete and formation of fungus</p>

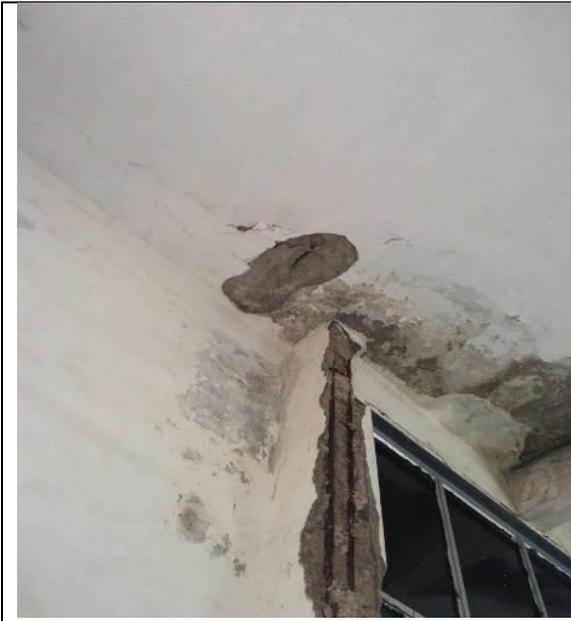
<p>C Wing Ground Floor: R/f exposed and corroded with fallen cover concrete of Slab</p>	<p>Passage Ground Floor: Termite Attack on RCC beam</p>

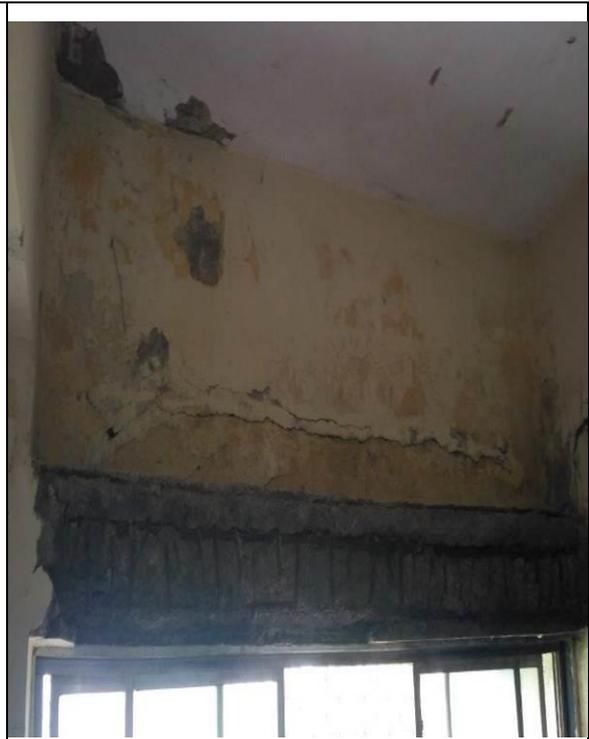
D Wing First Floor: Spalled cover concrete with exposed and corroded reinforcement

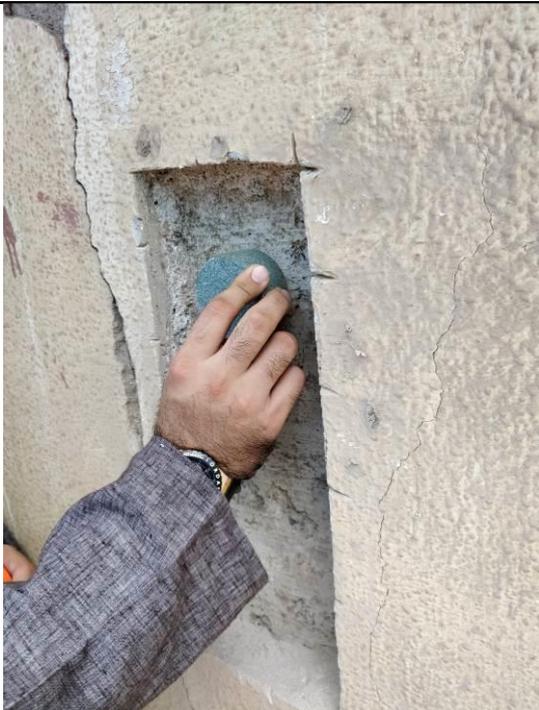
D Wing First floor: Delaminated cover concrete with exposed and corroded reinforcement of lintel

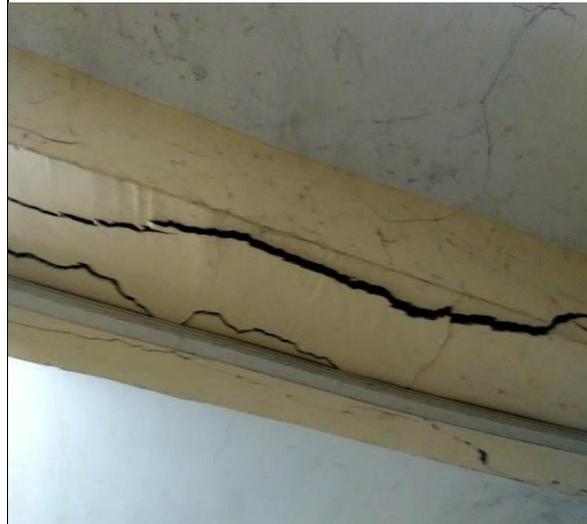
Cover concrete fallen and exposed/corroded reinforcement of beam at at C Wing 1<sup>st</sup> Floor

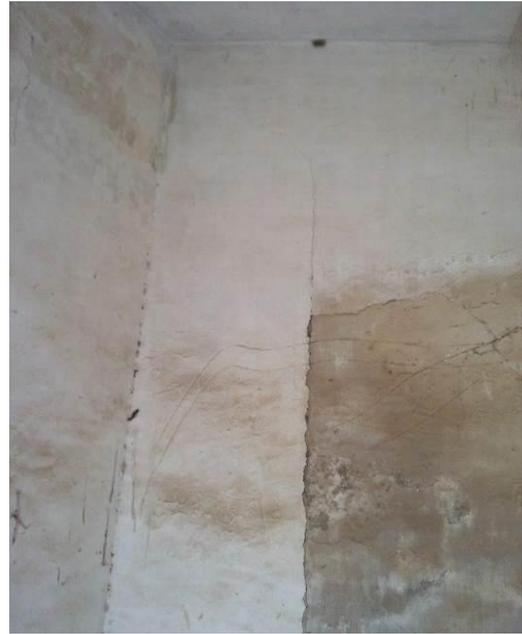
Wide vertical corrosion crack in RCC column through its length in Common Passage at few locations on 1<sup>st</sup> floor
