Static Balancing of Centrifugal Fan

Ekpenyong Ekpo¹, Samuel Audu Seth², Kario David Kelas³, Nasir Muhammad Yelma⁴

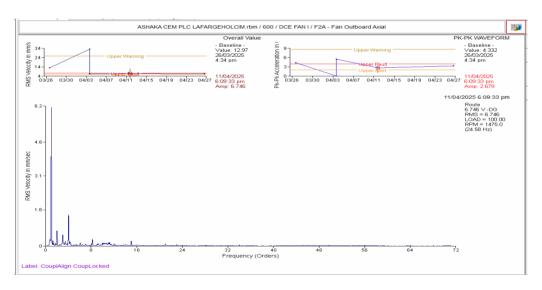
3. Post-Static Balancing.

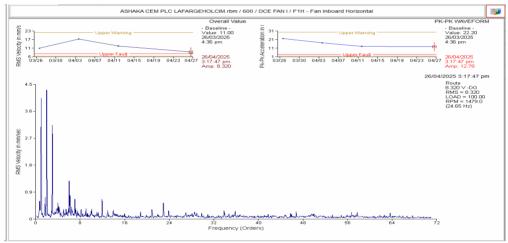
Figure 6a: Fan Drive End (FDE) – Horizontal vibration wave front
