Esthetic Rehabilitation Of Endodontically Compromised Teeth Using Glass-Fibre-Reinforced Posts: A Case Series

II. Case Presentation

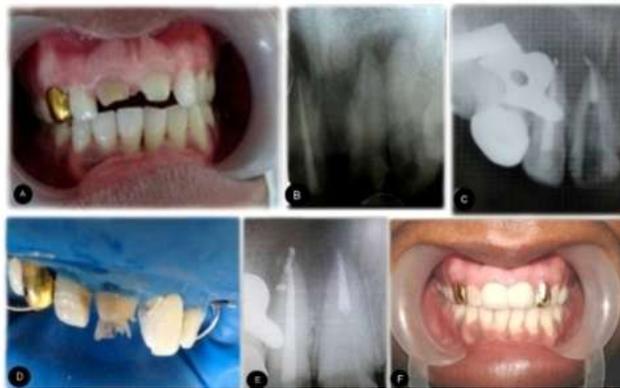
Figure 1- A) Pre operative intraoral photograph, B) Pre operative intra oral periapical radiograph, C) After caries removal & sectional Obturation, D) Post placement, E) Intraoral periapical radiograph after post placement, F) Post operative intraoral photograph after crown cementation.

An extra oral examination revealed no significant finding. On intra oral examination dislodged crown seen with both maxillary central incisors. “[Fig -1A]” Attempted root canal treatment with pus discharge was seen through left central incisor. Temporary restoration seen with right central incisor. Both central incisors

were tender on percussion. On thermal and electrical pulp testing left central incisor and both laterals were non-vital. On radiographic examination right central incisor was under-obtured, 2mm short of apex. Periapical radiolucency was seen with both central and lateral incisors. “[Fig -1B]”

After taking written informed consent, root canal treatment was carried out with both maxillary lateral incisors and left central incisor using standardized root canal protocol and calcium hydroxide as a intra canal medicament until canal was dry and significant periapical healing observed on the radiograph. “[Fig -1C]”

Re-treatment was started with right central incisor and after complete removal of gutta percha and caries, remaining dentin thickness was very less. So intra canal rehabilitation with glass fiber reinforced post (everStickPost, GC America INC. USA) was planned. After cleaning and shaping when the tooth was asymptomatic sectional obturation was performed by keeping gutta percha at the level of apical 5mm to maintain a good seal. “[Fig -1C]”

Tooth was isolated using rubber dam. Canal was irrigated with distilled water and dried with paper point. Depth of the canal was measured by using k file and stopper was adjusted 2 mm short of estimated crown height. Cut the post together with silicone sheet to a suitable length using sharp scissor. 1.5 size everStickPost (GC America INC. USA) was inserted and in upper portion of canal it was laterally condensed. Intra oral periapical radiograph was taken to confirm the placement of the post up to the desired length and density. Post was removed from the canal, for cementation low viscosity dual cure cement (ParaCore® Core Build-Up, Coltène/Whaledent USA) was used according to manufacturer’s instruction and post was slowly inserted into the canal. After removing excess cement post was light cured for 40 sec. “[Fig -1 D & E]” Core build up was carried out using composite. Then tooth preparation was done in relation to concerned tooth and full coverage porcelain fused to metal crown were luted using glass ionomer cement. (GC FujiCEM, GC India) “[Fig -1F]”.

Case I & III presented uniqueness in problem that the root walls were very thin, restoring the same with the traditional method would have resulted in the chance of fracture of root. And restoration with the pre-fabricated post would have resulted in obturation of the large defect with the cementing medium, which creates a very weak area in the entire post-core-crown-tooth complex.^[13] When everStickPost (GC America INC. USA) was used, preparation of the root canals need not be as extensive as with traditional posts. Thus, the dentine was saved and the risk of perforation was reduced. The pulp chamber of the root canal was completely filled with fibres instead of cement.^[14] In 2004, Anil Kishen et al., suggested that the structure of remaining radicular dentin is less mineralized and more collagenous, hence possess low modulus of elasticity.^[15] It is proposed in the literature that to prevent root fracture at least 1 mm of dentin be maintained around the entire circumference of the channel.^[16] So it was a necessity to place a everStickPost (GC America INC. USA) which reinforces the canal and transfer the occlusal load equally through out the canal. Good adhesion between post and cement and cement and dentin is one of the important factor in load transfer, so Everstick post was used because the monomers of the adhesive resins and cements can diffuse into the linear polymer phase, causes swelling of it, and by polymerization, it form inter-diffusion bonding which is called as secondary semi-IPN structure.^[17,18] Improved bonding allows transfer of loads from the crown-core system to the root trough the root canal post.^[4]

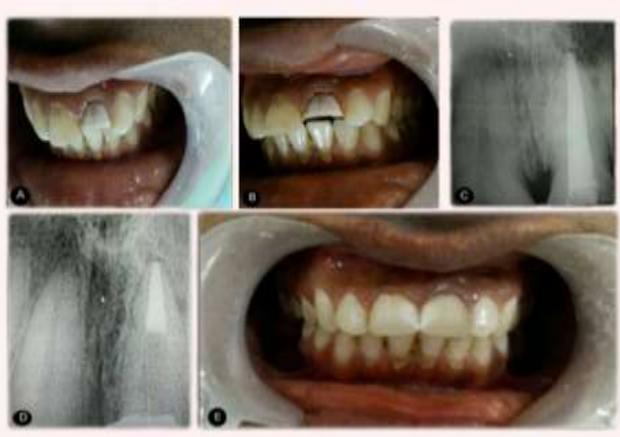
Figure 2- A) - Pre operative intraoral photograph, B) Maxillary left central incisor with reduced overjet, C) Pre operative intra oral periapical radiograph, D) Intraoral periapical radiograph after post placement, E) Post operative intraoral photograph after crown cementation.

32 years old male patient was came to the department having a chief complain of fractured tooth in upper front teeth region. Patient gave history of accidental trauma 2 months back followed by root canal treatment with maxillary left central incisors 1 month ago. Patient was asymptomatic. On clinical examination fractured crown seen with maxillary left central incisor with reduced overjet in anterior region. “[Fig -2A & B]” Radiographic examination revealed good root canal filling with fractured crown with maxillary left central incisor. “[Fig-2 C]”

Post and core followed by crown was planned. As patient was having reduced overjet, post which can be angulated was needed to get sufficient clearance. So everStickPost, (GC America INC. USA) was selected. Gutta percha was removed leaving apical 5mm of filling material. everStickPost (GC America INC. USA) placement was carried out, as per manufacture’s instruction mentioned in case I. “[Fig -2D]” Then tooth preparation was done in relation to concerned tooth and full coverage ceramic crown was luted using glass ionomer cement (GC FujiCEM, GC India). “[Fig -2E]”

Case II The individual everStickPost (GC America INC. USA) were chosen because of the angle between the root and the crown part of the incisor with reduced overjet. The pre-manufactured fibreglass posts would not have been as effective as they do not allow any individual shaping of the post.^[5]

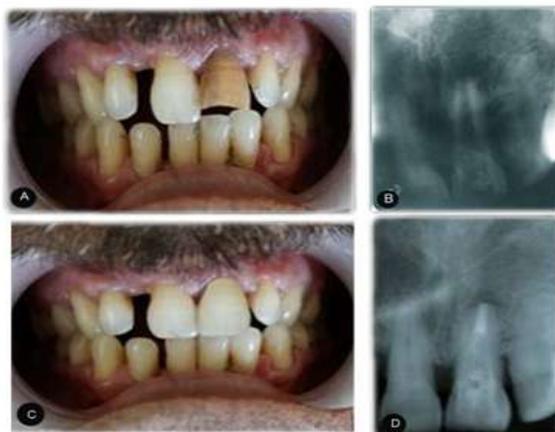
Figure 3- A) Pre operative intraoral photograph, B) Pre operative intra oral periapical radiograph, C) Post operative intraoral photograph after crown cementation. D) Intraoral periapical radiograph after post placement.

42 years old male patient was came to the department having a chief complain of discoloured tooth in upper front teeth region. Patient gave history of accidental trauma 4 year back, and root canal treatment were started 1 year back with the same. Intraoral examination shows Ellis class I fracture with discoloration of maxillary left central incisor. “[Fig -3A]” Tenderness was positive on percussion. On radiographic examination root resorption with open apex was seen. And remaining dentin thickness was very less. “[Fig -3B]” So apexification by using MTA and intracanal rehabilitation by using glass fibre reinforced everStickPost (GC America INC. USA) followed by crown was planned.

After complete cleaning and shaping of the canal, apexification was done using MTA to create 5mm apical plug. Intracanal rehabilitation was done using everStickPost (GC America INC. USA) as manufacture’s instruction mentioned in case no I. “[Fig -3D]” Then tooth preparation was done in relation to concerned tooth and full coverage ceramic crown was luted using glass ionomer cement (GC FujiCEM, GC India) “[Fig -3C]”
