## Scanning Electron Microscopic Analysis and Bond Nature of Dual Forms of Resin Repaired and Thermocycled Crystalline Lithium Disilicate Ceramic

**Aim:** The aim of this in vitro study was to qualitatively assess the mode of failure of dual forms of resin repaired lithium disilicate ceramic.

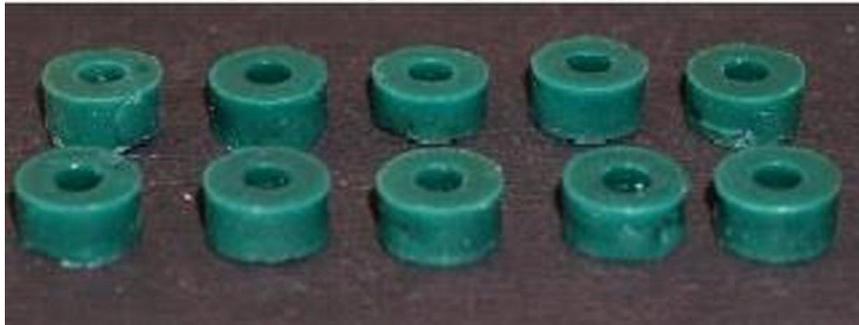
**Fig1a Group I wax pattern Bilayered**

A total of 11 wax patterns with height 3mm, diameter 10mm, with central defect of diameter 4 mm which simulates the fractured site and debonded ceramic site of the restorations were prepared for bilayered lithium disilicate ceramic test samples as Group I, another 11 wax patterns with height 5mm, diameter 10 mm with central defect well of diameter 4mm which simulates the fractured site and debonded ceramic site of the restorations were prepared for monolithic lithium disilicate ceramic test samples as Group II were fabricated using customized stainless steel jig. (Fig. 1a,1b).

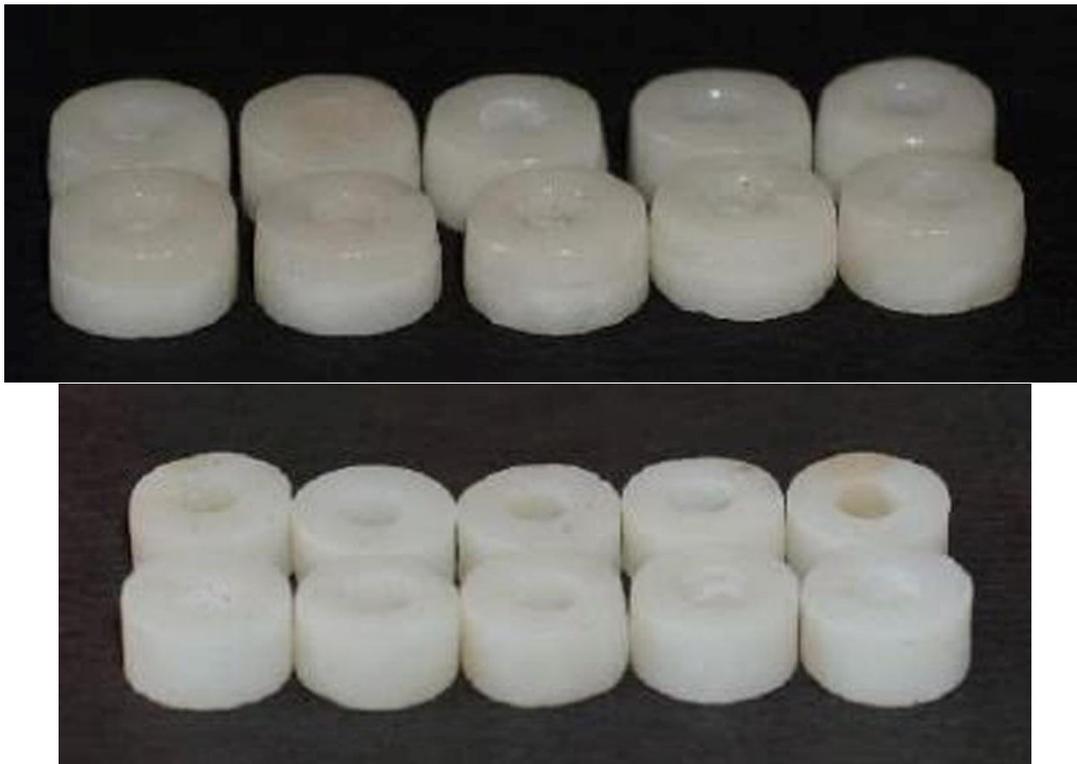
**Fig 2a,2b -Group I and Group II – ceramic samples( Bilayered& Monolithic )**

11 wax patterns for Group II were sprued and invested, pressed and finished following all necessary protocol as followed for Group I except the layering procedure which is not needed for Group II. Thus all 20 test samples with their specified dimensions were obtained. (Fig. 2a,2b)

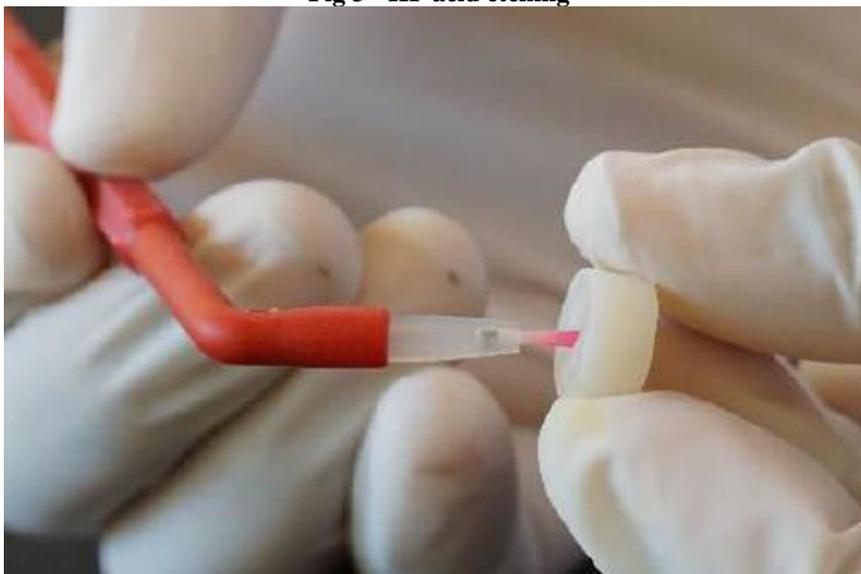
**Fig 3 - HF acid etching**

The surface of defect well of test samples from groups I &II were etched with 5% HF for 20 seconds. The samples were then rinsed with distilled water for 1 minute and air dried. (Fig. 3 & 4)

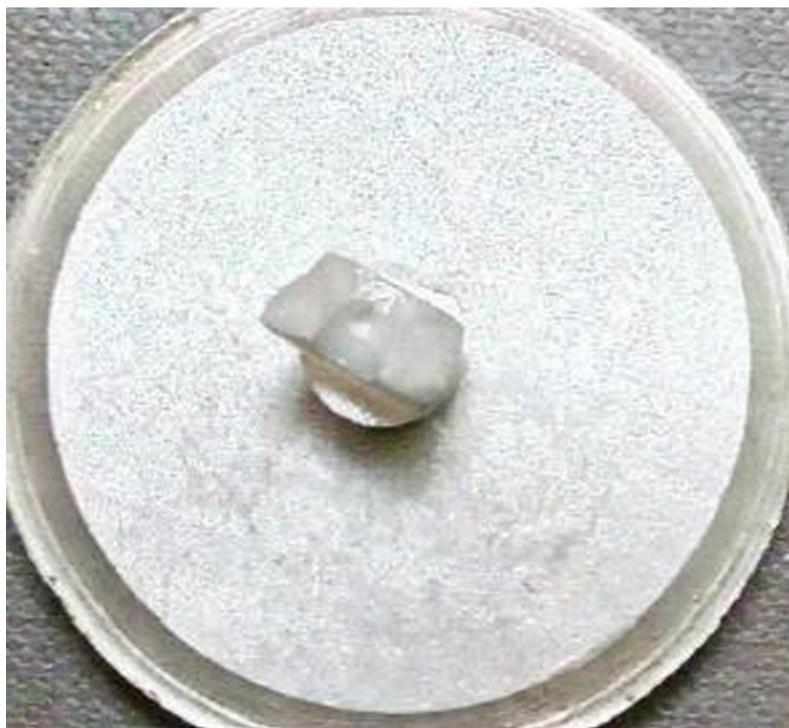
**Fig 5 Quality analysis of the surface characteristics of the etched surface of test samples by SEM**

One representative test sample was randomly taken from each test group for qualitative analysis of etched surface using scanning electron microscope (S- 3400N, Hitachi High Technologies Corporation, Japan). The sample was coated with a layer of gold using gold sputtering system and was examined at 2000X magnification to assess the surface characteristics (**Fig. 5**)

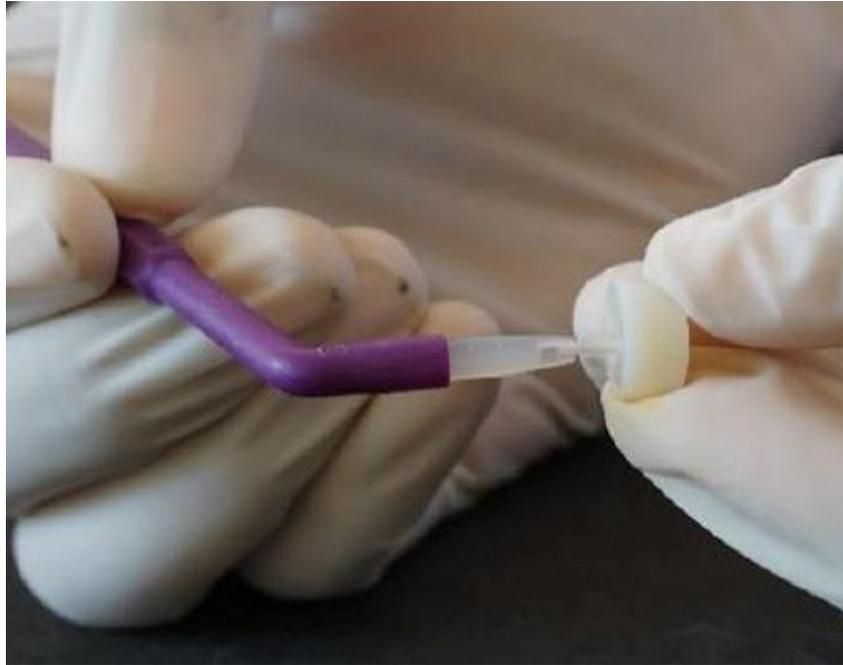
**Fig 6 Silanization of etched surface**

silane coupling agent was applied to the defect well and allowed to react for 60s (**Fig. 6**) After Silanization, bonding agent (Heliobond, IvoclarVivadent, Schaan, Liechtenstein) was applied in a thin layer to the entire surface of the defect well (**Fig. 7**). The bonding agent was then cured for 10 seconds using a light cure unit (**Fig. 8**). Repair composite resin (Tetric N-Ceram, IvoclarVivadent, Schaan, Liechtenstein) was filled in individual increments of 2mm + 2mm + 1mm using a customized incremental jig and light cured for 10 seconds respectively(**Fig.9 & 10**). In this manner the defect well was filled until the 5mm depth was achieved.

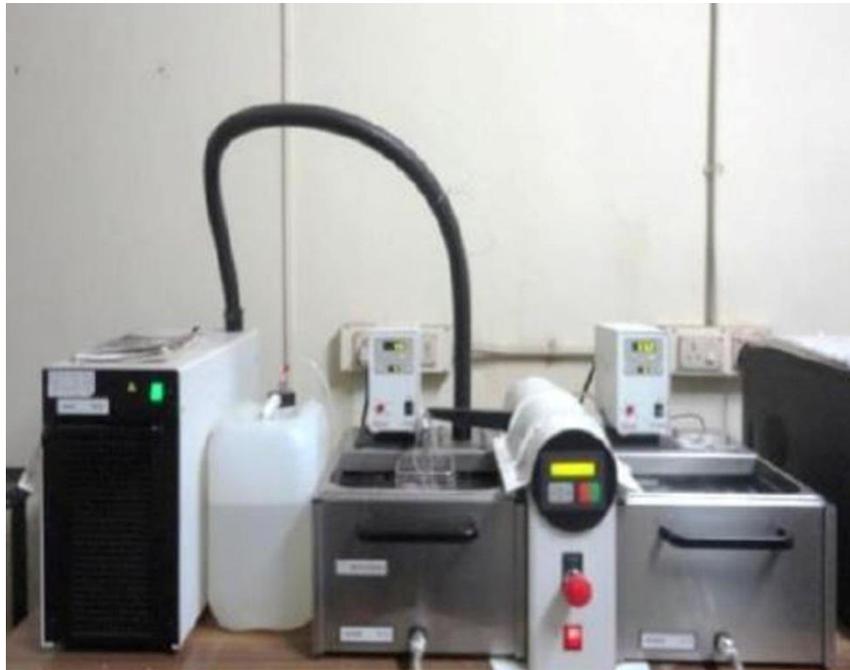
**Fig 11- Thermocycling of the test samples**

The test samples were stored in distilled water in individual containers for 24 hours at 37°C. Then the test samples were subjected to thermocycling for a total of 250 cycles in a distilled water bath between 5°C and 55°C with a dwell time of 60 seconds and a dry time of 10 seconds at 27°C using a thermocycling apparatus (Haake, W15, Germany) to simulate three months of clinical use. (Fig. 11). Upon completion of thermocycling, the test samples were again stored in distilled water in their respective containers till they were subjected to shear bond testing.

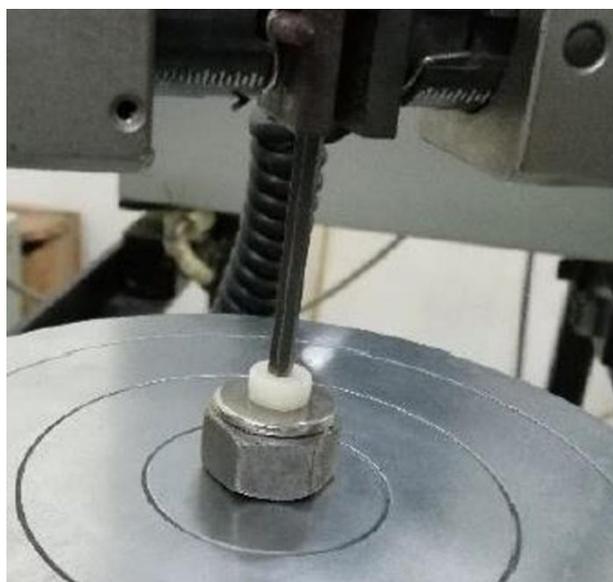
**Fig 12 Shear testing of the test sample**

The test samples were subjected to shear bond testing individually in the universal testing machine (Instron 3382 100 KN, UK). The test samples were placed on the fixture with a ball ended pin of 4mm diameter positioned perpendicular to samples (Fig. 12). Force was applied to the test sample in such a way that the shear load was exerted directly on the whole of the repair composite surface at a cross head speed of 2mm/min until failure of the bond occurred. Shear bond force at which the bond failed was recorded in Newton (N) and shear bond strength (MPa) was calculated by dividing the force (N) at which failure of the bond occurred by the surface area of adhesion ( $\text{mm}^2$ ). The tested samples were stored in distilled water again.

Shear bond strength test was performed by applying the force parallel to the bonding interface<sup>[21, 44, 45]</sup> and the shear bond strength was calculated by dividing the maximum load (in N) to the surface area (in mm<sup>2</sup>) of the composite resin. Shear bond strength value (in MPa) is the stress on the unit of area.<sup>[44]</sup>

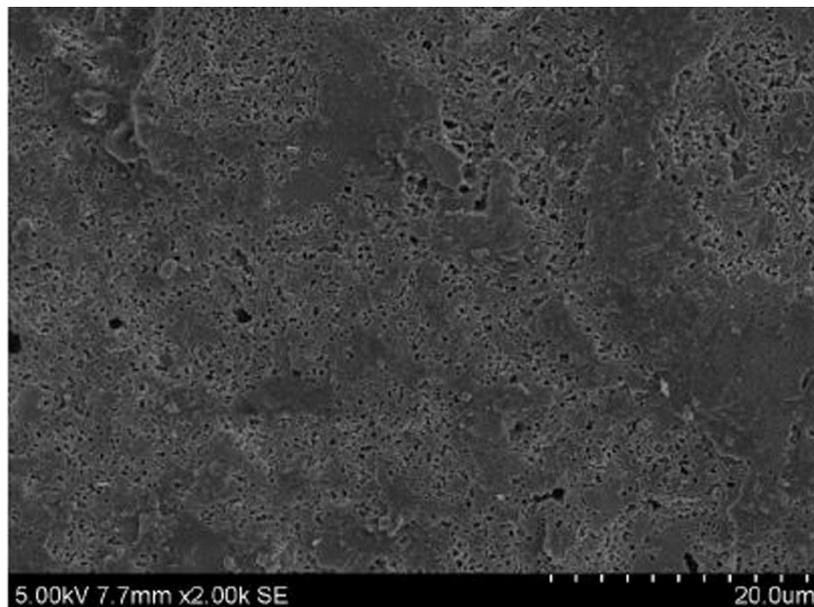
**Fig 13 Qualitative analysis of the etched surface of Group I sample ( Bilayered group)**

Shear bond strength values of Group I, showed low bond strength value when compared to Group II. Studies focusing on shear bond strength between repair resins bonded to lithium disilicate with layering are lacking, hence, shear bond strength values of Group I cannot be compared with the previous studies. Also, values obtained in this study were below the clinically accepted limits (5.34 ± 1.37 MPa). SEM photomicrograph (**Fig 13**) of pre-repaired etched surface (after 20s etching) of Group I representative sample (nanofluorapatite) sample, under 2000X magnification, revealed presence of both undissolved and dissolved surface topography.

There were significant areas of unetched ceramic surface present throughout the observed field, which could be one of the reasons for the low bond strength in first group. SEM photomicrograph of pre-repaired etched surface (after 20s etching) of Group II representative sample (lithium disilicate), under 2000X magnification image revealed significant change in surface microstructure as compared to that observed for Group I etched surface. The etched surface showed, a predominantly irregular surface characterized by numerous micro porosities in the form of pits, grooves and few striations, that were present throughout the observed field. Fewer areas of undissolved glassy phase of lesser dimensions were also visible, interspersed between the predominantly etched surfaces. And this image appeared similar to the images obtained by the previous authors in their respective surface topography study.<sup>[34]</sup>

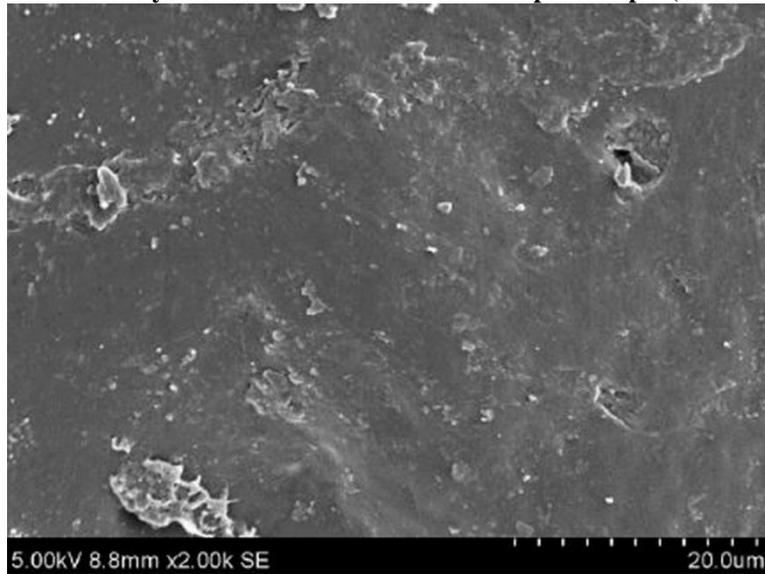
**Fig 14 Qualitative analysis of the etched surface of Group II sample ( Monolithic group)**

The mode of failure pattern observed was indicative of a vulnerable bond at the ceramic-repair resin interface. Group II SEM image at 2000X magnification also showed a predominantly irregular surface. There were increased areas of the ceramic material of greater thickness distributed over the resin surface, throughout the observed field, indicative of a mixed mode of failure that was predominantly cohesive in nature within the ceramic. The mode of failure pattern observed was indicative of improved bonding at the ceramic-repair resin interface. It appears from the results of the present study that the repairs of monolithic lithium disilicate ceramic restorations have a better survival rate as compared to bilayered lithium disilicate ceramic restoration. **(Fig14,15,16).**

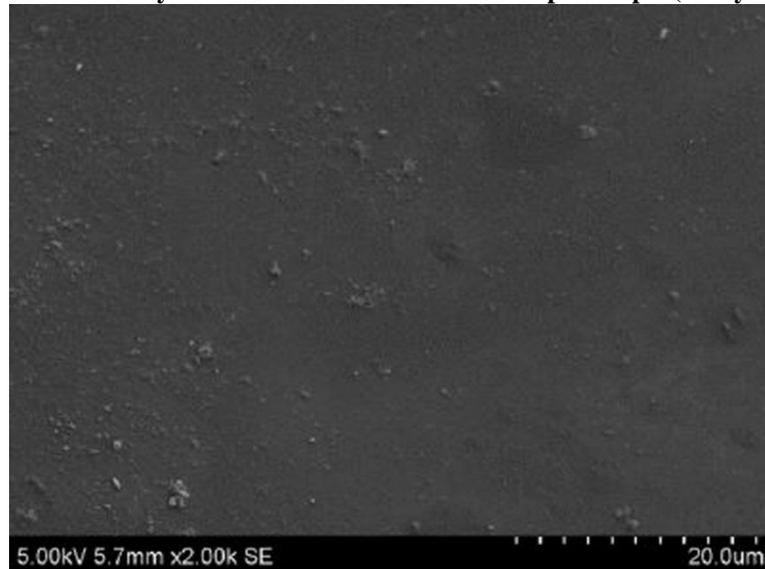
**Fig 15 Qualitative analysis of mode of the failure of Group I sample ( Bilayered group)**

Thermal cycling, an artificial aging method of dental materials, which causes thermal strain on the bonding surface by influence of liquids and thereby thermal change is simulated.<sup>[19, 26]</sup> These could be the reasons for low bond strength for Group I. Shear bond values of both groups tabulated in the present study showed that Group II bond strength value was approximately 15MPa and consequently could be considered sufficient for clinical application. The difference between our results of Group II and those of other studies may be due to several factors such as differences in the concentration of HF used, types of composite resins used, different surface treatment methods in repair process and different testing conditions. Based on the results obtained in this study, the null hypotheses was rejected, because there was high statistical significant difference between the two tested groups ( $p < 0.05$ ). SEM analysis was done on the repair composite resin surface bonded to bilayered and monolithic lithium disilicate ceramic restorations, Group I SEM image at 2000X magnification showed, predominantly smoothen resin surface with sparsely distributed isolated areas of ceramic material, indicative of a mixed mode of failure that was predominantly adhesive in nature between repair resin and ceramic.

After shear bond testing, tested samples were subjected to SEM analysis to assess the mode of failure. SEM analysis at 2000X magnification was done on the repair composite resin surface that got sheared from the defect well of test sample during testing.
