Geo-Scientific Evaluation, Kinematics Analysis, and Mitigation Strategies for Pagal Nala landslide along Rudraprayg to Joshimath (NH-07) road corridor, Garhwal Himalaya

Nalini Das¹, Rajendra Kumar Rawat²

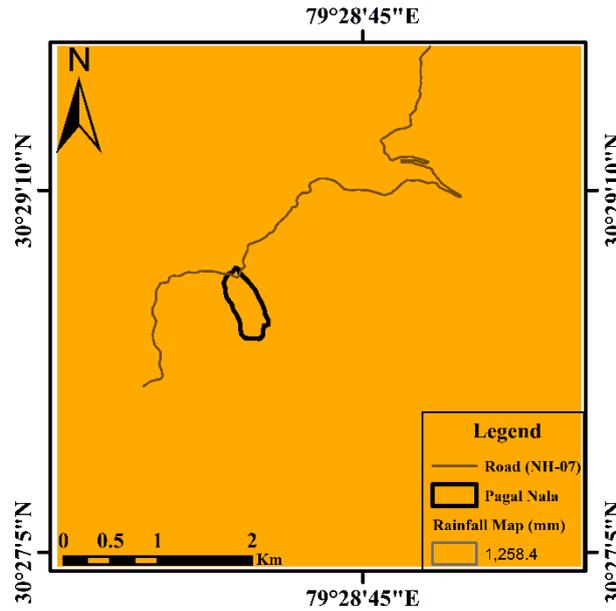
Rainfall has also been instrumental in initiating the Pagal Nala landslide, as can be seen in the 30-year CHIRPS ($0.05^{\circ} \times 0.05^{\circ}$ resolution) record where it is receiving nearly 1258.4 mm of rainfall per year (**Fig. 3**). In an unsound geomorphological and structurally incompetent environment such as that of Pagal Nala, such rainfall serves as the main initiation factor of slope instability (Shi et al., 2025). Progressive long term and high magnitude precipitation saturates the slope material progressively, mainly the weathered meta-basalt, limestone, and meta-quartzite units of the Berinag Formation. This lowers matric suction, raises pore water pressure, and consequently lowers the shear strength of the slope-materials. Rainwater seeps into bedding planes, joints, and foliation surfaces, frequent in this tectonically deformed belt, weakening the subsurface. Hence, the combined impact of intensity and duration of surplus precipitation is responsible for triggering as well as remobilizing the landslides in the area.

Fig. 3 Chirps Rainfall map where slide area found within 1258.4 mm rain cover (30 years average of mean annual rainfall)

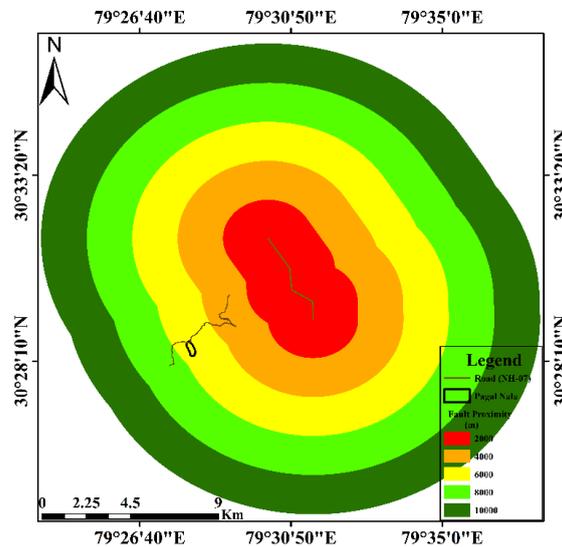
Fault proximity has had a great effect on the Pagal Nala landslide since the location of the slide is within 6000 meters of the Main Central Thrust (MCT), as shown by the fault proximity map (Fig. 5). This kind of tectonic proximity exposes the area to extreme deformation, fracturing, and shearing, and therefore leads to greatly jointed and weakened rock masses (Xie et al., 2025). Tectonic perturbations induce lower cohesion and shear strength of the slope-producing material, hence increasing its likelihood of failure (Coffie-Anum et al., 2024).

Fig. 5 illustrates the Fault proximity map where slide is found within 6000 m range of the Main Central Thrust.

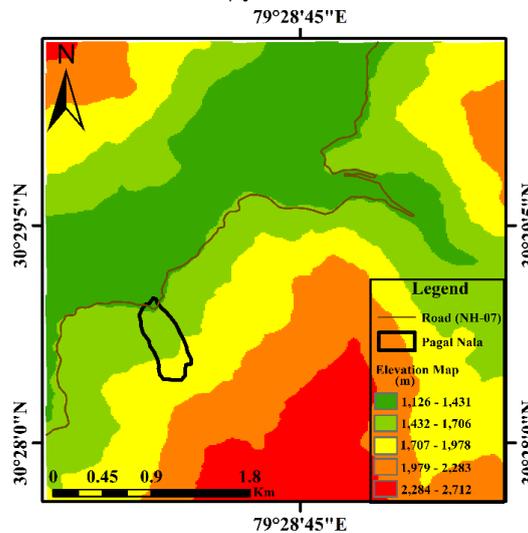
Elevation has been a major contributory factor in the Pagal Nala landslide, whose affected area ranges between 1400–1850 meters, as indicated by the elevation map (Fig. 6). The elevation is also known to overlap with the mid-slope steep areas where gravitational forces will be greater and slope inclinations will be greater (Barrie et al., 2024). These areas are prone to colluvial debris accumulation, bedrock exposure, and increased intensity of weathering, all factors contributing towards the decrease in slope stability. Furthermore, orographic processes at this height can induce localized precipitation, which brings about greater infiltration and runoff (Holden & Burt, 2002). Coupled with tectonic as well as anthropogenic pressures, elevation-driven topographic stress also plays a major role in the landslide susceptibility of this area.

Fig. 6 depicts the Elevation map, where slide area found within the elevation ranges of 1400 to 1850 m.
