# Structural Health Monitoring And Repairs: A Case Study From Mumbai

This paper presents a case study of a two story (G+2) institutional building, it is framed structure made of RCC columns, beams & slabs. Age of the building is in the range of 47 to 50 years as per the construction. Structural audit was conducted for proposed repairs, rehabilitation, and retrofitting of an existing building. The structural health monitoring was conducted using visual inspection, detailed distress mapping, and non-destructive tests. The structural health monitoring is a crucial tool for assessing the condition, serviceability, and safety of the structure. It helps in identifying risk areas, critical areas, and the need for immediate attention. The structural health monitoring also investigates the impact of changing the building's use from residential to commercial or industrial on its performance. The purpose of the audit is to save life and property, assess the extent of distress, estimate the residual life of the structure, highlight critical areas, advise residents/owners/users about the problems' seriousness, comply with statutory requirements, and select an effective remedy. This paper empha

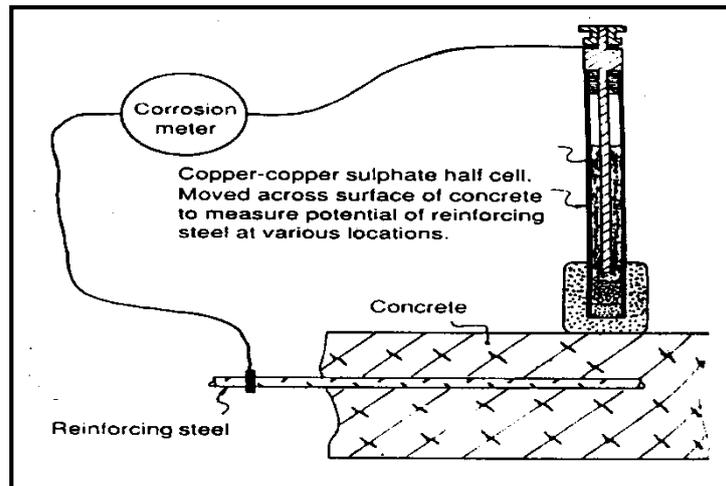
**Fig. 1: Half-cell Potential Test**

The instrument as shown in Figure 1, measures the potential and the electrical resistance between the reinforcement and the surface to evaluate the corrosion activity as well as the actual condition of the cover layer during testing. The electrical activity of the steel reinforcement and the concrete leads them to be considered as one half of weak battery cell with the steel acting as one electrode and the concrete as the electrolyte. The name half-cell surveying derives from the fact that the one half of the battery cell is considered to be the steel reinforcing bar and the surrounding concrete. The electrical potential of a point on the surface of steel reinforcing bar can be measured comparing its potential with that of copper – copper sulphate reference electrode on the surface. Practically this achieved by connecting a wire from one terminal of a voltmeter to the reinforcement and another wire to the copper sulphate reference electrode. Then readings taken are at grid of 1 x 1 m.

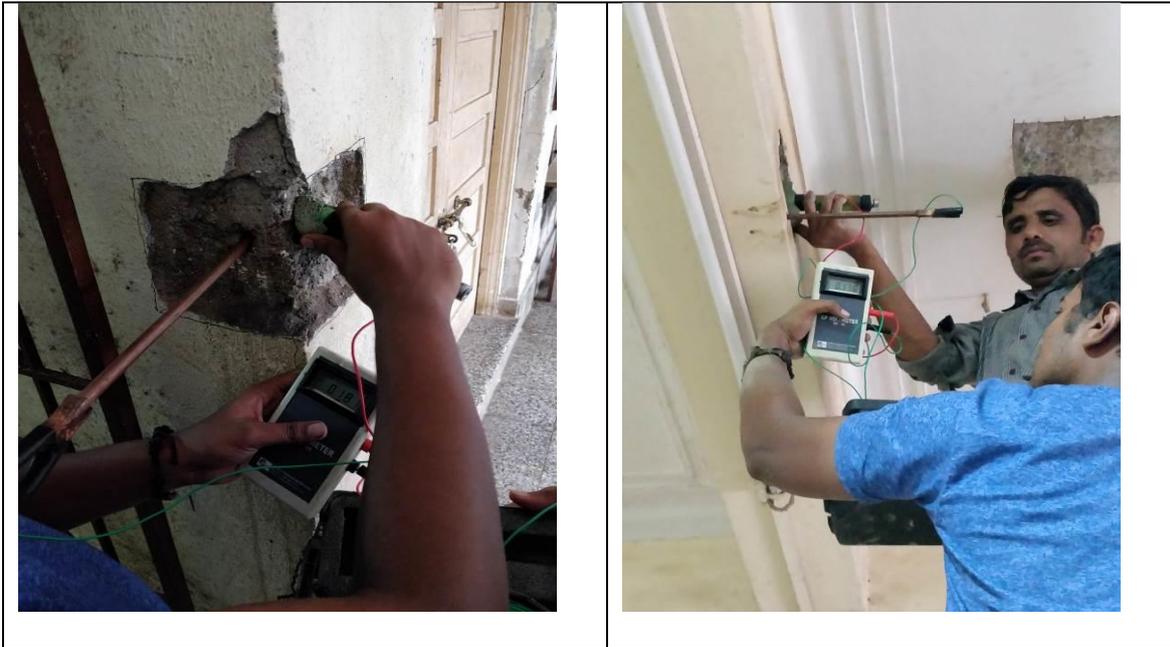
Corrosion Test by Half Cell Potentiometer

Half-cell potentiometer indicates the probability of corrosion ranging from Moderate to High level. From visual inspection & Half-cell potentiometer test it is evident that moderate to high corrosion activity is present.

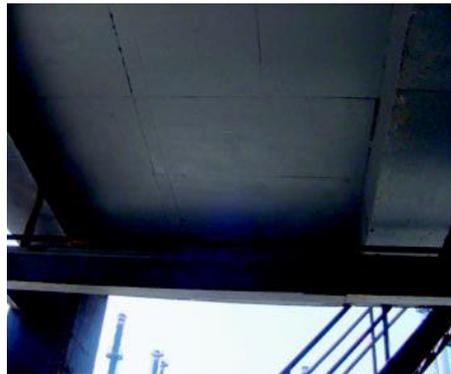
**Fig: 16 Slab view from bottom after rehabilitation**

Step 10) Apply two coats of a high build solvent free epoxy resin of 500  $\mu$  DFT, after all the floor surface are cleaned thoroughly using a concrete cleaning and etching agent. It may be noted that lot of local site decision have to be taken depending on the site conditions. The Fig (14) indicates the slab after inclusion of new reinforcement: The above procedure has been followed with a meticulous planning and rehabilitation work had been carried out with great care under expert supervision and skilled and specialized workers when the units are in operating condition. However, certain areas, where permit could not be obtained, due to safety of the plant work was carried out during shutdowns. The slabs after repair were intact and looking newly built. Thus, the life is enhanced. The fig. 16 depict the slab after repair.
